Durability of the hydrophobic treatment on brick and mortar

Published in:
Building and Environment

ABSTRACT

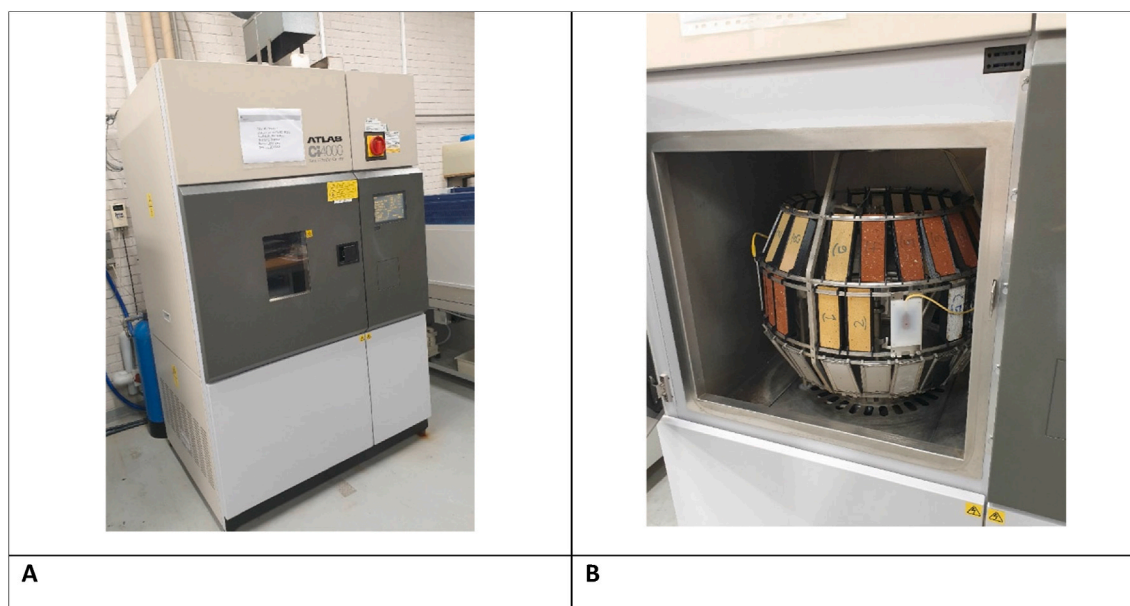
Fig. 1. Test setup for artificial aging. A) Atlas Ci4000 weather-ometer and B) test specimens on carousel sample holder inside the chamber.

To evaluate the durability of the hydrophobic surface treatment on brick and mortar, artificial aging was conducted, according to ISO 4892–2 [42], with Atlas Ci 4000 weather-ometer, at the Danish Technological Institute, Taastrup (Fig. 1). ISO 4892 [42] is targeted at the durability of plastics but its key features (UV radiation and water spray) are in line with [29], also performing artificial weathering of hydrophobized porous building materials in Atlas weather ometer. The samples were placed in plastic holders that cover the edges (from the 75 cm² of the samples' face surface, only 57.8 cm² are exposed to water spray and UV radiation). The plastic holders were placed on a carousel, inside a climatic chamber. The samples were exposed to sprayed water and UV radiation only from the interior of the carousel. The water repellency performance is evaluated by the water absorption coefficient (A_{cap}) of the samples, obtained via water uptake tests in accordance with [43], as described in Refs. [44,45]. The samples were placed in a plastic container with deionized water that covered less than one cm of the sample, over plastic net support, for 1-D free capillary water uptake. The mass of the sample was determined with a balance reading 0.001 g and the samples were wiped with wet paper before each measurement. Since impregnation decreases the rate of capillary water uptake, the water uptake tests for the impregnated samples lasted for 24 h and the time intervals for the measurements were: 10', 30', 1h, 1h 30', 2h, 3h, 4h, 7h, 9h, and 24h. When displaying water uptake in kg/m² towards $\sqrt{\text{seconds}}$

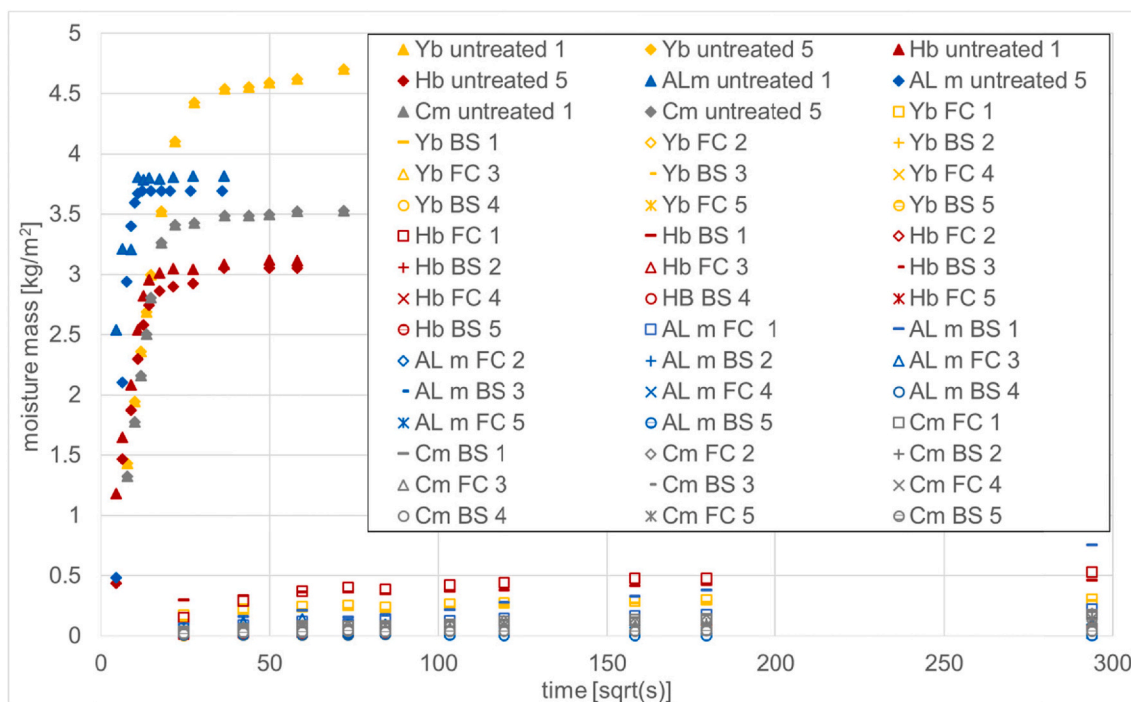
Fig. 2. Capillary water uptake of Y brick, H brick, C mortar, AL mortar, untreated and impregnated with Remmers FC cream 40% and Wacker BS cream C 80%. 1: 1st water uptake before artificial aging, 2: 2nd water uptake after 165 cycles of artificial aging, 3: 3rd water uptake test after 335 cycles of artificial aging, 4: 4th water uptake after 482 cycles of artificial aging, 5: 5th water uptake after 635 cycles of artificial aging. Each point of each curve is the average value of the respective measurements of three different samples.

Fig. 2 illustrate the capillary water uptake curves both of untreated and treated samples during the artificial weathering while Fig. 3 shows

only the treated samples. The water uptake curves of all the treated samples were significantly reduced compared to untreated. The moisture mass difference against sqrt(s) did not give a straight line, but could follow a curve of some form (Fig. 3).

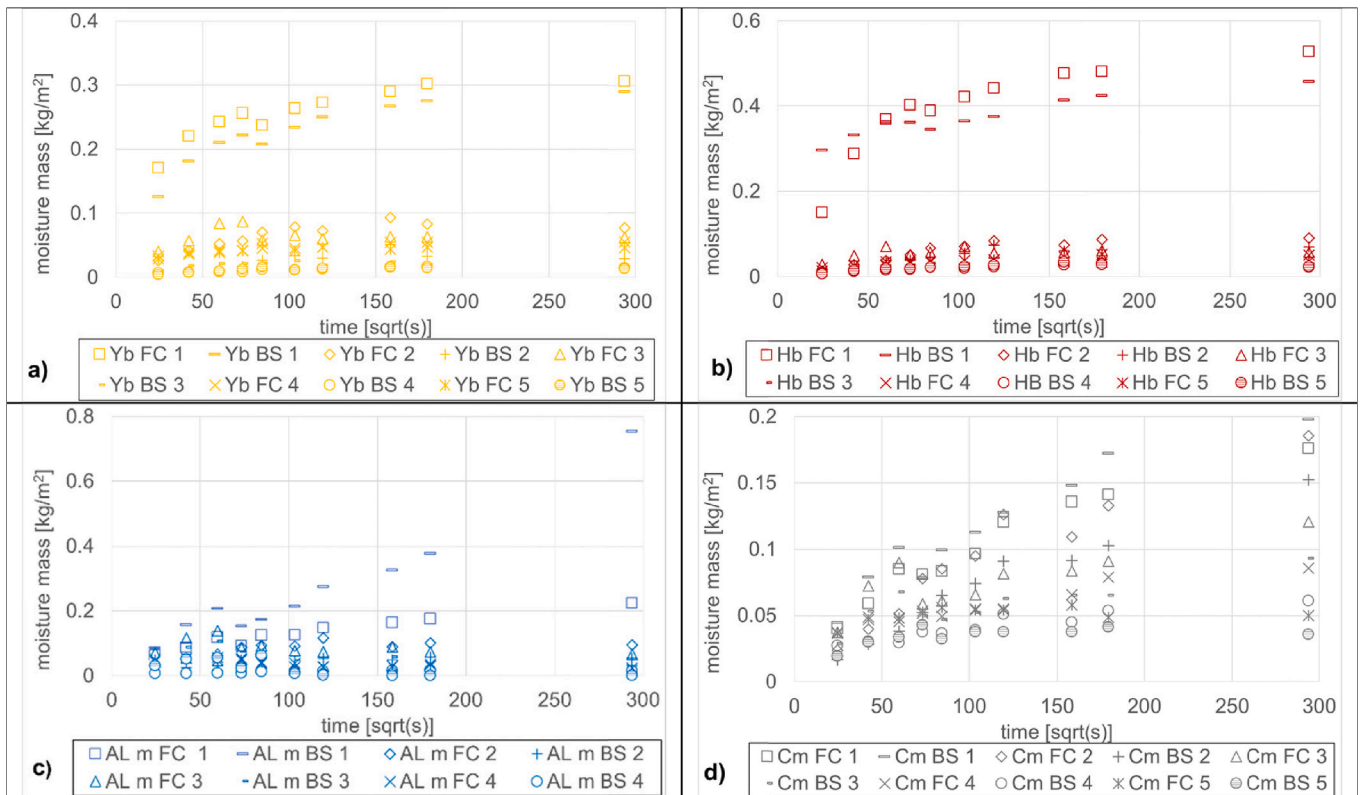
Fig. 3. Capillary water uptake of a) Y brick, b) H brick, c) AL mortar, d) C mortar, impregnated with Remmers FC cream 40% and Wacker BS cream C 80%:1: 1st water uptake before artificial aging, 2: 2nd water uptake after 165 cycles of artificial aging, 3: 3rd water uptake test after 335 cycles of artificial aging, 4: 4th water uptake after 482 cycles of artificial aging, 5: 5th water uptake after 635 cycles of artificial aging. Each point of each curve is the average value of the respective measurements of three different samples.

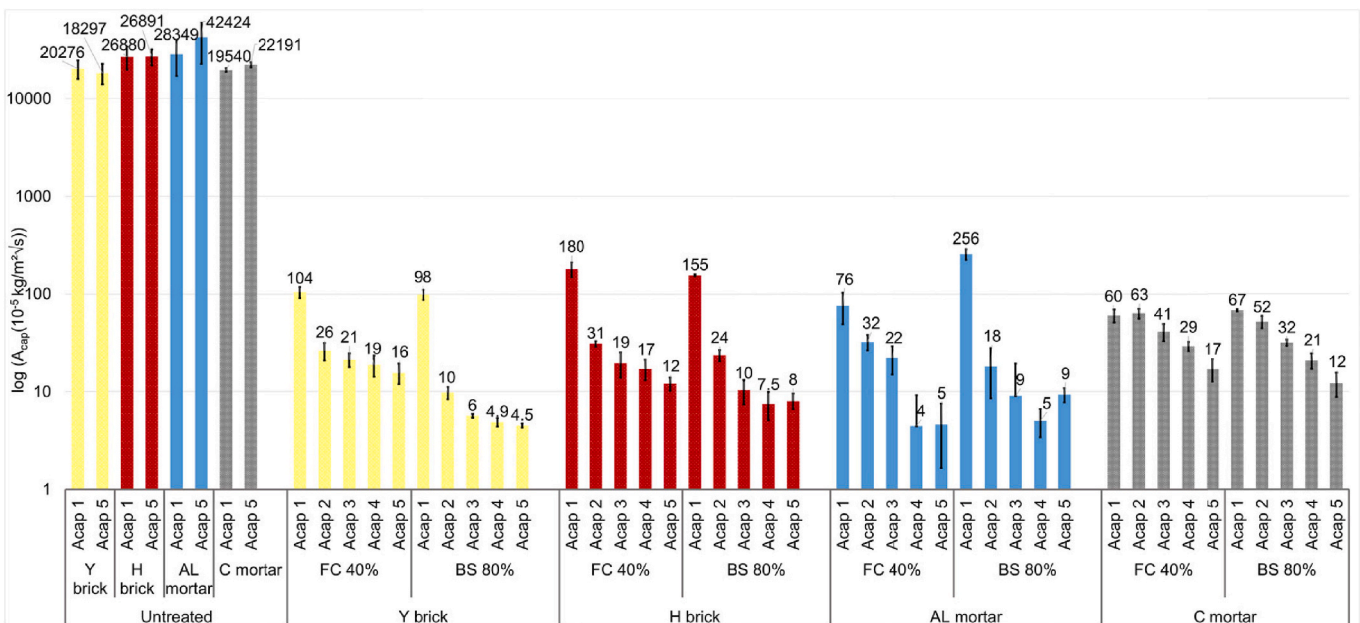
Fig. 4. Water absorption coefficient by capillary water uptake test of Y brick, H brick, AL mortar, C mortar, untreated and impregnated with Remmers FC cream 40% and Wacker BS cream C 80%. Acap 1: absorption coefficient before artificial aging, Acap 2: after 165 cycles of artificial aging, Acap 3: after 335 cycles of artificial aging, Acap 4: after 482 cycles of artificial aging, Acap 5: after 635 cycles of artificial aging. Each result is an average based on three samples, error bars correspond to standard deviation.

Fig. 4 focuses on the water absorption coefficient of the different samples during the testing period. The untreated samples did not show

significant changes in the water uptake after 635 cycles of aging. All treated samples showed reduced water uptake after treatment, and the water uptake was further reduced during the aging period.

The absorption coefficient on the first test before aging was reduced approximately by a factor of 200 due to hydrophobization (e.g Y brick treated with FC 40%, A_{cap1} : $0.00104 \text{ kg/m}^2\text{s}^{1/2}$ from untreated A_{cap} : $0.2 \text{ kg/m}^2\text{s}^{1/2}$) and was further reduced by a factor of more than 1000 (A_{cap5} : $0.00016 \text{ kg/m}^2\text{s}^{1/2}$) after aging for all the tested materials, compared to untreated. Consequently, the ability of the hydrophobization to reduce water uptake is not diminished by the performed artificial aging. The absorption coefficient seems to be positively influenced by artificial aging since it is further reduced during the process of repeated cycles.

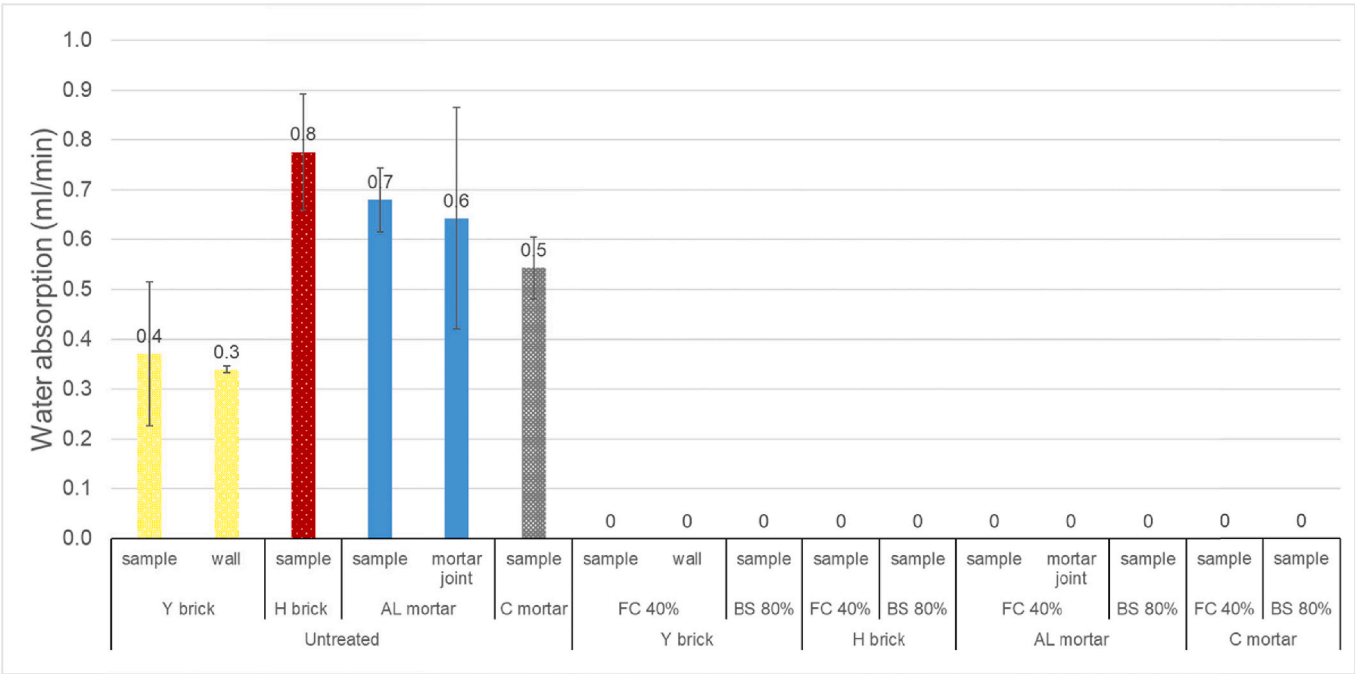
Fig. 5. Water absorption by Karsten tube test, Y brick, H brick, AL mortar, C mortar, and mock-up wall, untreated and impregnated with Remmers FC cream 40% and Wacker BS cream C 80%. “Sample” refers to samples from artificial aging, “wall” and “mortar joint” refer to mock-up wall measurements on brick and mortar joints respectively. Each result is an average based on three measurements, error bars correspond to standard deviation.

The Karsten tube test, as an additional indicator, supported the observation that hydrophobization blocked liquid water transport even after aging in brick and mortar since the water penetrated neither samples nor brick and mortar joints of the mock-up wall hydrophobized six years ago (see Fig. 5). Also, the water absorption of untreated brick and mortar samples was similar to untreated bricks and mortar joints of the mock-up walls, as seen in Fig. 5.

Mortar joints are regarded as the weak point of a masonry facade [28], however, they are not easy to characterize with a Karsten tube test. During Karsten tube tests on the mock-up wall (Fig. 5) it was challenging to adjust the glass tube on the mortar joints without having leakages. Especially, in buildings with concave mortar joints, it would be very difficult to test the water uptake with the Karsten tube test. Karsten tube is an accurate method for testing water uptake on bricks but it is more difficult to give accurate results on mortar joints [54]. Additional in-situ measurement equipment, not available for this study, covers wider wall areas [55]. However, the impregnation depth is reported to be lower in mortar samples and mortar joints than in bricks [21,28], and the possibility of cracks after treatment is higher in mortar joints, as well as in the interface between bricks and mortar joints. Moreover, brick absorbs the water repellent agent much faster than mortar [21]. During the application process of the cream products, a percentage of the cream placed in the mortar joints would be absorbed by the brick, leaving less active ingredient for the mortar joints. Furthermore, since the beading effect is reduced due to UV radiation exposure, the water is being absorbed into the first mm of the substrate and during winter this water may freeze, expanding its volume and induce spalling. If this continues to occur and mortar joints start to crumble, cracks may reach untreated areas after years. This could also happen to brick although less possible as the impregnation depth is larger [21]. These observations indicate that mortar joints should be studied further.
